This whistleblower complaint is filed by the International Association of Sheet Metal, Air, Rail and Transportation Workers (SMART), as well as the individual Kingspan employees signed below against Kingspan Light + Air (“Kingspan”). We ask that your offices (collectively, the “State Board”) investigate Kingspan’s compliance with its Storm Water Pollution Prevention Plan (“SWPPP”) at its manufacturing facility located in Santa Ana, California (“Facility”). Kingspan has a recent history of discharging metals and other substances into the stormwater above the levels permitted by law. It is currently under a Level 2 ERA Action Plan for aluminum, iron, and zinc and a Level 1 Action Plan for Total Suspended Solids. Kingspan revised its SWPPP as recently as December 2020 to reflect these action plans.

## **II. The State Board should investigate Kingspan’s compliance with its SWPPP.**

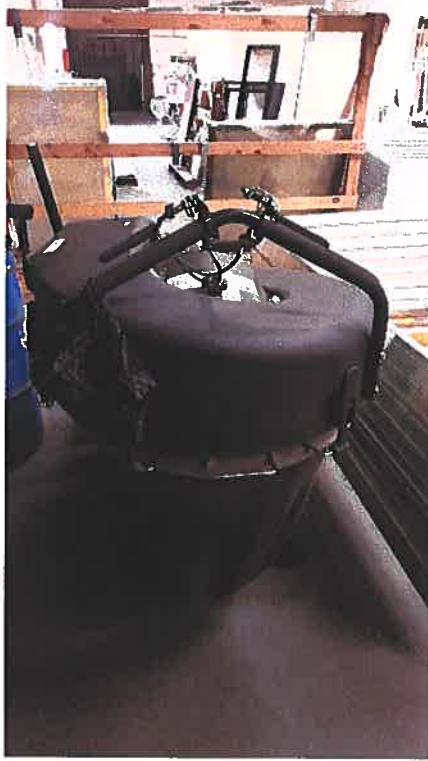
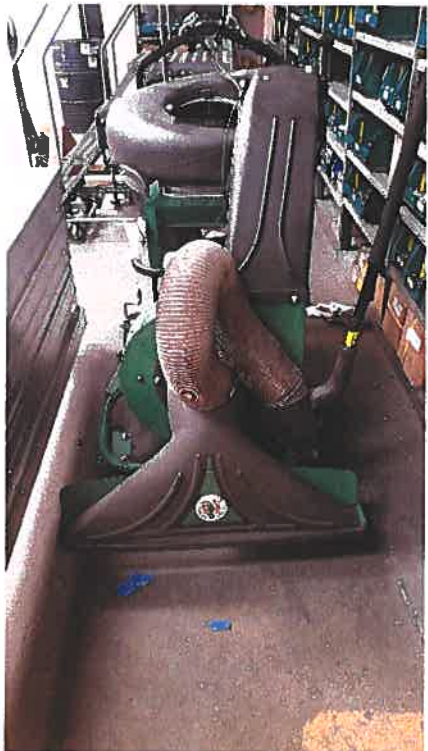
Photo 1: vacuum stored inside assembly department September 16, 2021:

Kingspan employee Israel Maldonado stated that the vacuum was stored in his work area in Building 401 ever since the company acquired it. He recalled that to have been in or about December 2020. He never saw it taken from his work area, except for the brief period that Millan used it in about June 2021. Millan also stated that he saw it there when he was assigned to work in assembly in August 2021. A copy of the photo of the vacuum taken on September 16, 2021, is attached in the Appendix as Photo 1.

On or about September 10, 2021, we encouraged Coastkeeper to request Kingspan to provide copies of the vacuuming logs for review in accordance with the federal consent decree. Thereafter, on or about September 13, 2021, Fernandez asked Millan to complete several papers. Fernandez stated the papers were for "the court." Millan states that soon after, Kingspan hired a new employee to clean outside. Millan observed this employee taking the vacuum from where it was stored in the assembly department and using it from that point.

Based on the foregoing, we believe that Kingspan's statements regarding its implementation of the vacuum BMP were incomplete and inaccurate. It did not use the vacuum from June 2021 until sometime around September 14, 2021, and based on Maldonado's observations, it had not been used since it was purchased in late 2020. Not only did Kingspan not engage in regular vacuuming as per the SWPPP, Millan used a leaf blower to blow dust and debris. Blowing dust and debris would seem to amount to the exact opposite of vacuuming it. While Kingspan may recently have started using the vacuum in response to inquiries by Coastkeeper, its failure to do so when it not under such scrutiny raises concerns about the ongoing viability of this BMP.

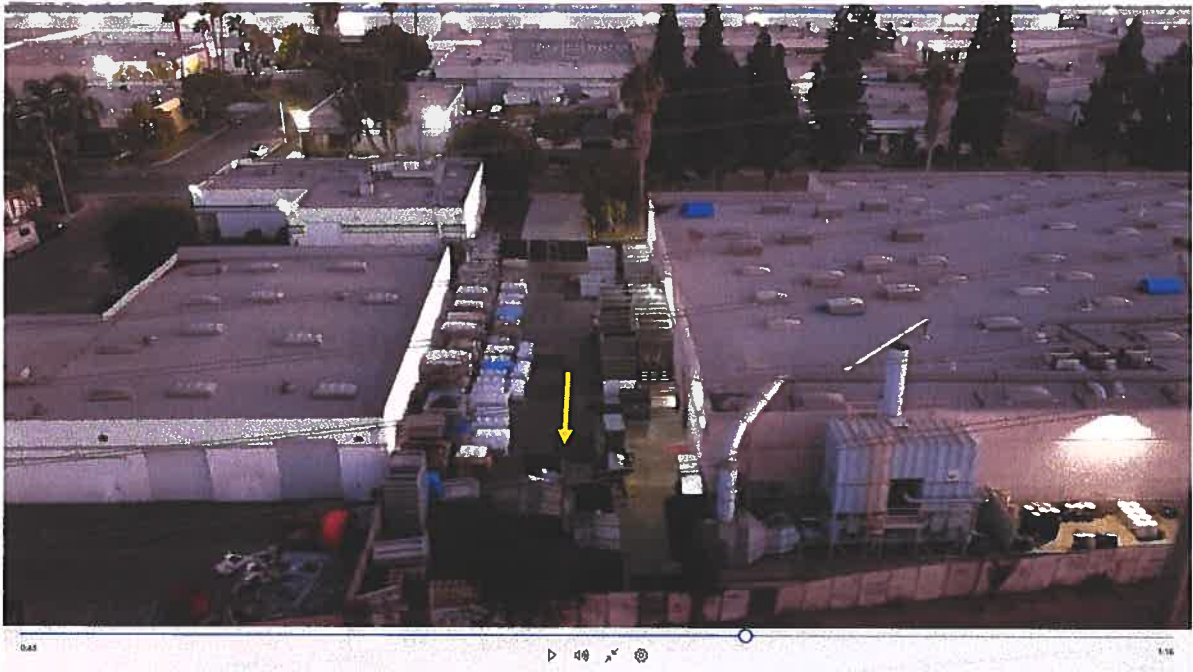
Photo 2: Dumpsters—NE corner outside 401 E. Goetz (viewed from north).

To address these potential sources of pollution, Kingspan described as a “minimum” BMP in the SWPPP: “[a]dd a lid to the uncovered dumpster located in the northeast corner of the 401 E. Goetz facility.” (SWPPP, p. 3-6.) In the TSO, Kingspan stated that “[a]ctivity associated with the trash bins can contribute to zinc discharges to the stormwater. As an interim BMP, this dumpster will be covered when not in use to minimize potential pollution associated with debris and particulates.” (TSO p. 4-1.) Furthermore, as a justification for the requested extended time schedule to meet effluent limits, Kingspan stated that the “existing trash bins and dumpster will be covered as an interim BMP.” (TSO, p. 7-1.)

However, Kingspan workers have stated that they have witnessed that the dumpsters are not consistently covered when not in use. To follow up on these accounts, SMART obtained aerial photographs of the Facility. (See Appendix, photos 2-3.) These photographs were taken on September 20, 2021, shortly after 7 p.m., after production hours. They depict what appear to be dumpsters located on the northeast corner outside of the 401 E. Goetz building that are not covered.

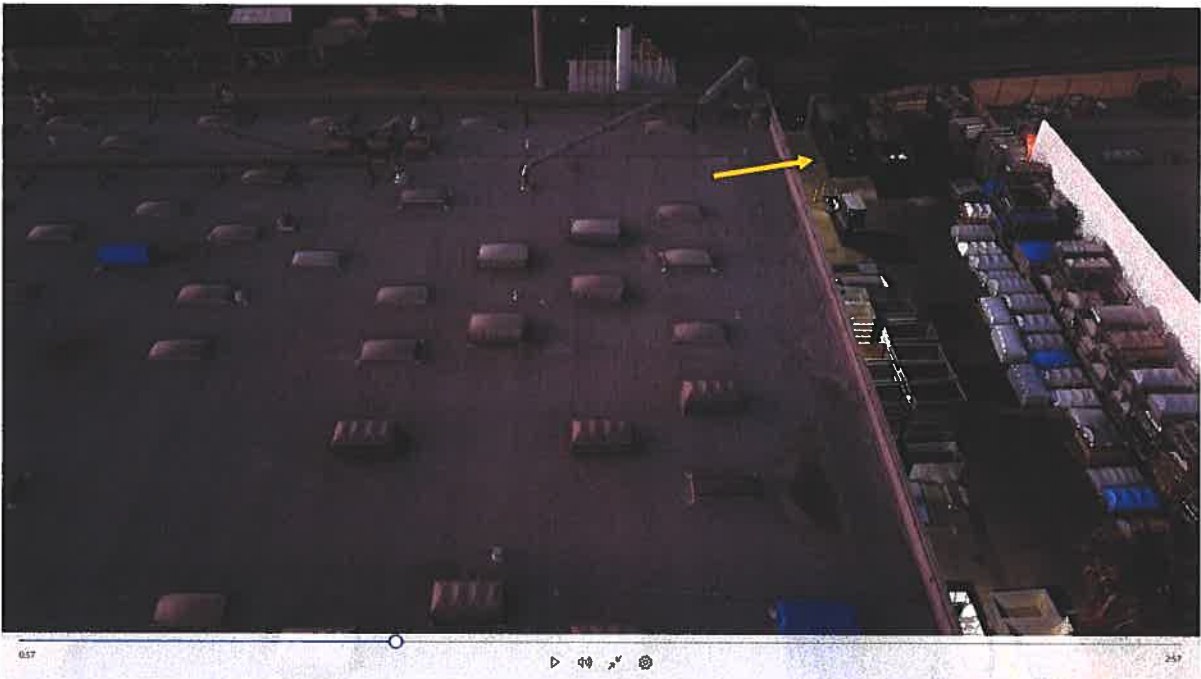
Photo 3: Dumpsters—NE corner outside 401 E. Goetz (viewed from south).

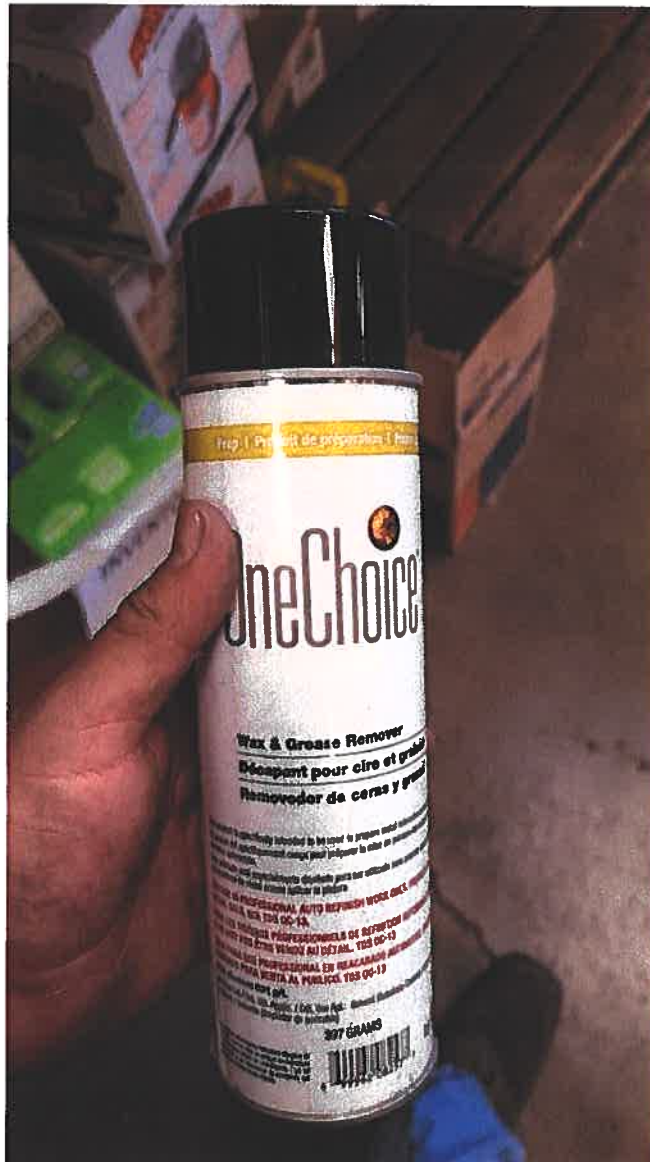
Photo 5: Wax and grease remover  
Foto 5: Removedor de cera y grasa.

In Appendix C to its SWPPP, Kingspan identifies industrial materials that are handled by the Facility. However, workers report that galvanizing spray paint is being used, as well as spray cans of One Choice wax and grease remover (see photo 5). Neither of these products are listed in Appendix C. One worker estimates that during a typical shift the employee responsible for spray painting uses eight cases of eight cans (64 cans) of galvanized paint. This painting does not go on in a spray booth, but on the shop floor in a curtained area with apparently no mechanical ventilation or air filtration system. While it has not been confirmed what brand of paint is utilized at Kingspan, galvanizing spray paint typically is made up of 40-70 percent zinc, owing to its rust proofing capacity. The State Board should investigate the type of spray paint utilized in order to ensure its proper inclusion of Appendix C.
